## **2026 Nepal rock-ice avalanche, debris flow and flash flood: preliminary assessment**

### **Highlights:**

- Satellite imagery enabled rapid interpretation of the 2026 Nepal disaster.
- The event involved cascading glacier–bedrock failure and a sediment-rich flood.
- Glacier retreat and fractured bedrock may have preconditioned the slope for failure.
- The disaster caused major geomorphic changes, infrastructure damage, and secondary hazards.

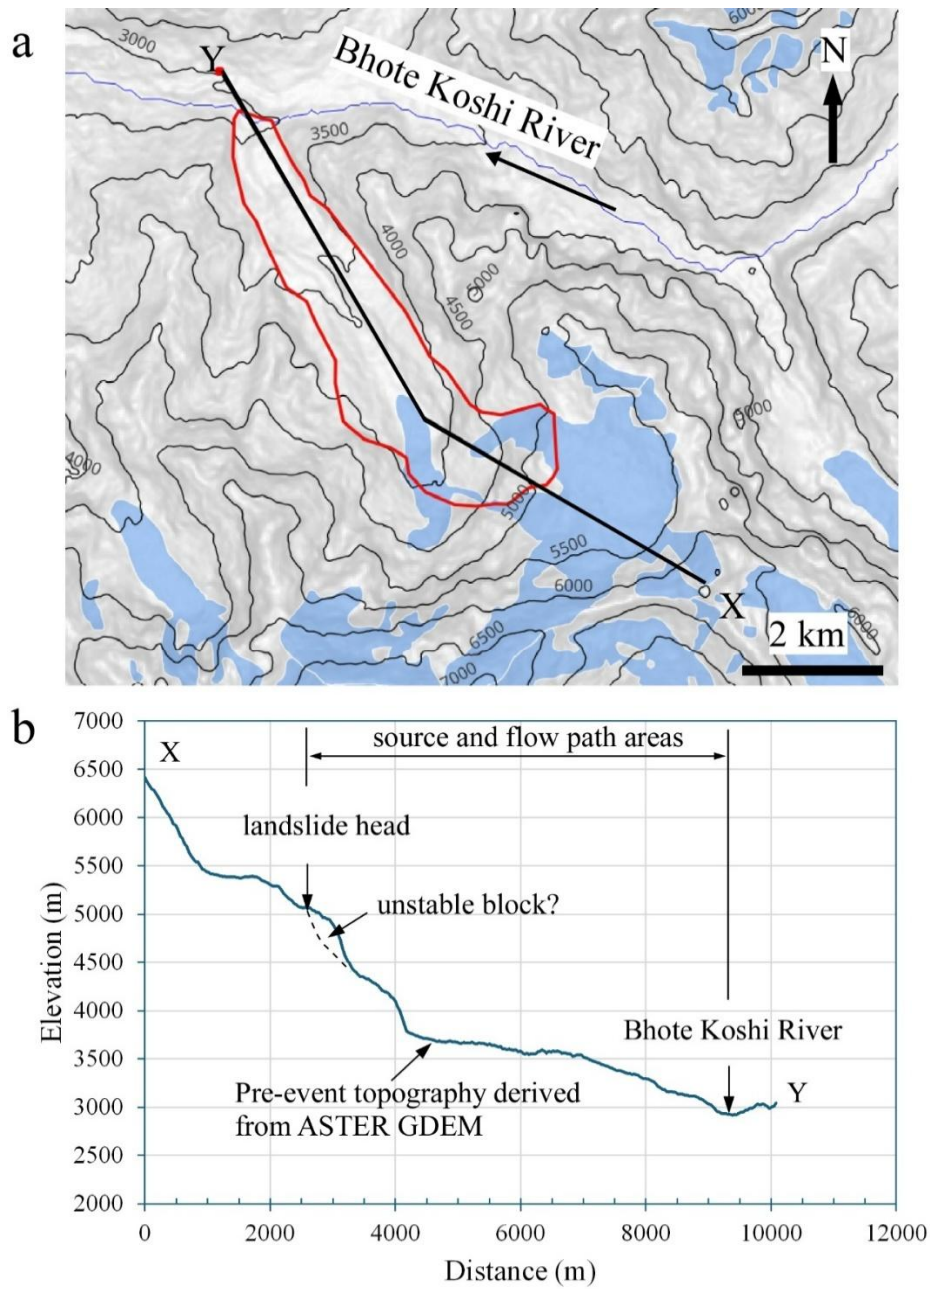
The source area is located at the terminus of a glacier at an elevation of approximately 5,060 m a.s.l., on a steep, high-relief mountain slope comprising glacier ice and underlying bedrock (Fig. 1). The source area has a maximum width of approximately 1.8 km and, together with the initial flow path, covers approximately 7.8 km<sup>2</sup>. The area is characterized by high relief, steep slopes, and a narrow, confined valley system (Fig. 1).

Fig. 1 Pre-event topography and longitudinal profile of the 2026 rock-ice avalanche source area and flow path. (a) Topographic map showing the landslide source and initial flow-path areas (red polygon). The black line from X to Y indicates the transect used to construct the longitudinal profile. Blue polygons indicate the distribution of glacierized areas based on Pfeffer et al. (2014). Contour lines and the underlying slope image were derived from the ASTER Global Digital Elevation Model (GDEM). (b) Longitudinal elevation profile along the X–Y transect, showing the landslide head and inferred unstable block.
